TECHNICAL REPORT HL-88-5

# OLD RIVER OVERBANK STRUCTURE, LOUISIANA

## Hydraulic Model Investigation

John L. Grace, Jr., Noel R. Oswalt, Edward D. Rothwell

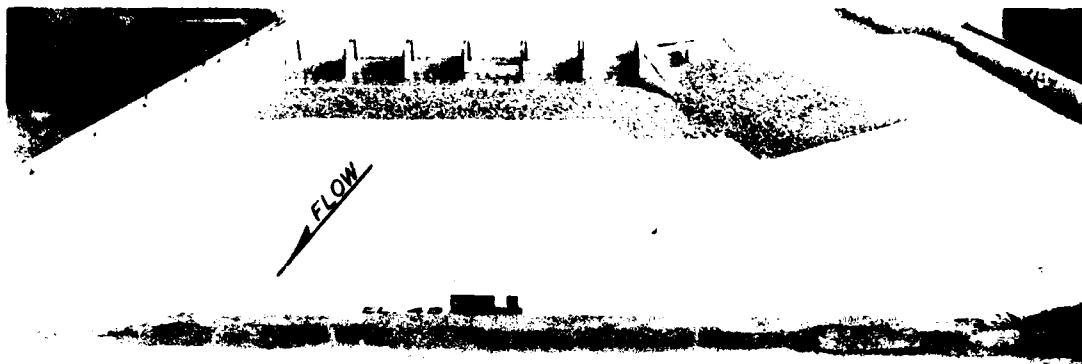
a. Overall view of model width (526 ft)

b. Closeup view of structure and left abutment

c. Upstream approach area

Figure 2. 1:25-scale dry-bed model

4. Two spillway section models with scales of 1:25 and 1:44 were used to investigate the hydraulic performance of the stilling basin and evaluate riprap stability and scour potential to be expected with the existing overbank structure under both the immediate and long-range operating conditions. The study was conducted to evaluate performance of the existing stilling basin with the various headwater and tailwater conditions with (a) all bays fully open, (b) alternate bays fully open and fully closed, and (c) controlled flow through various configurations of panels in each bay of the structure to evaluate the necessity for major structural and/or operational modifications. The stability of the existing riprap protection and scour potential were also investigated for the full range of anticipated operating conditions to assess the need for structural or operational modifications.

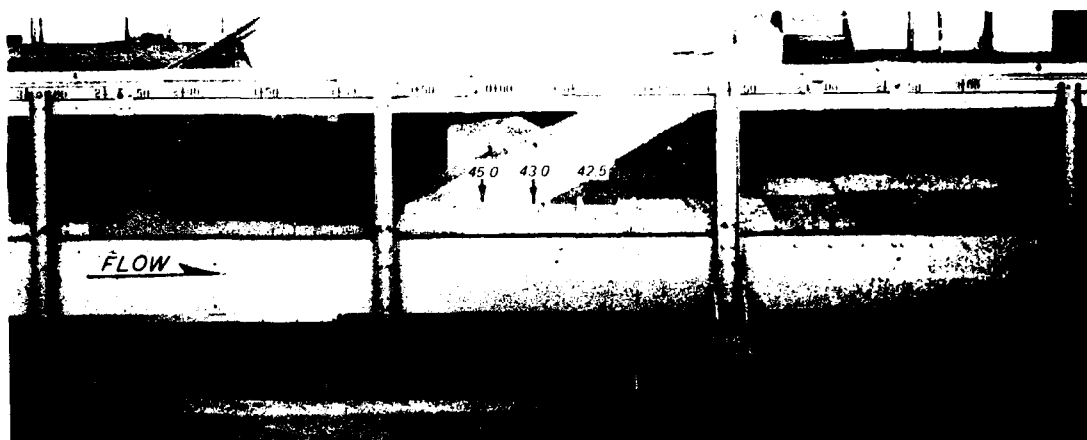
a. Overall view of one gate bay, upstream approach and downstream channel

b. Side view of one gate bay

Figure 3. 1:44-scale dry-bed section model

7. Initially, it was planned that all tests would be conducted using the 1:25-scale section model. However, it was found necessary to conduct a series of tests using a 1:44-scale section model simulating one 44-ft-wide spillway bay and 800 ft of the approach and exit channel in a 1-ft-wide glass-sided flume (Figure 3). These tests were conducted to identify and evaluate various types of flow conditions associated with a full range of expected operating conditions and to supplement various tests conducted in the 1:25-scale section model.

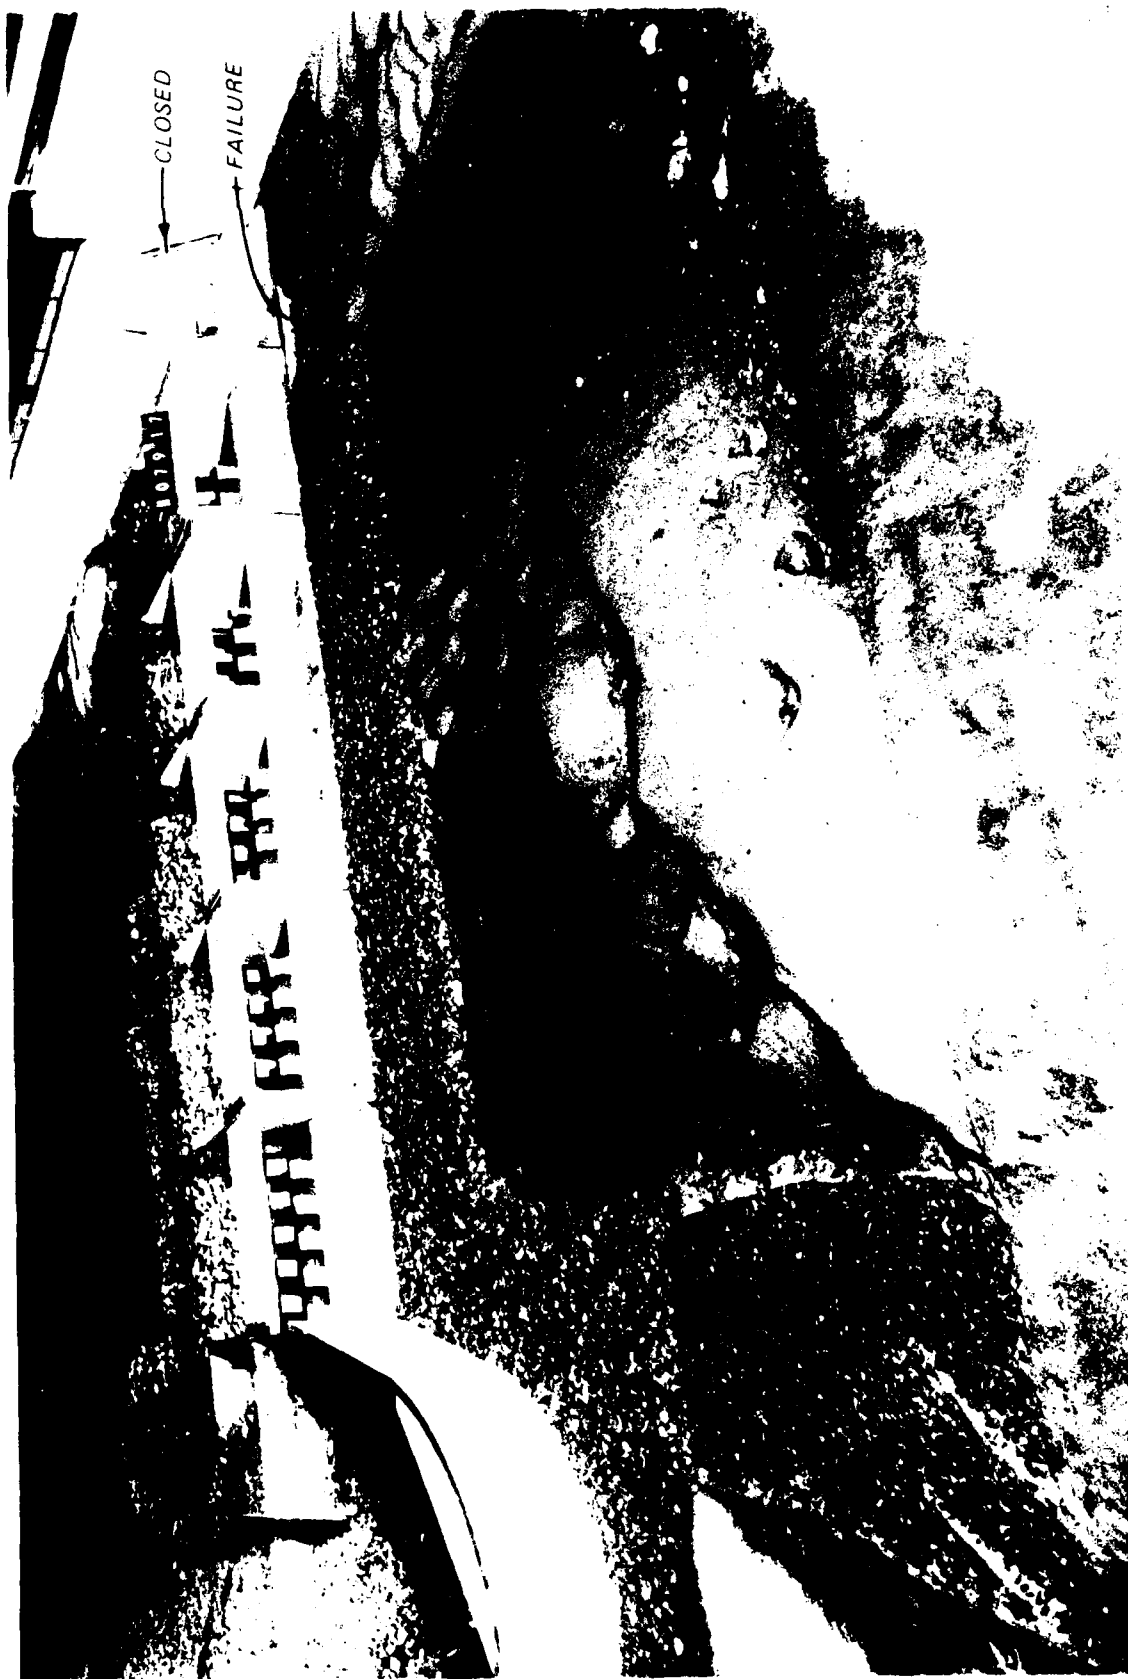
Photo 24. Areas of instability and scour potential, existing riprap, alternate bays fully open and closed, headwater el 68.0, tailwater el 56.0
